## Chapter 9

# FIRE BEHAVIOR IN WORLD TRADE CENTER 2

### 9.1 INTRODUCTION

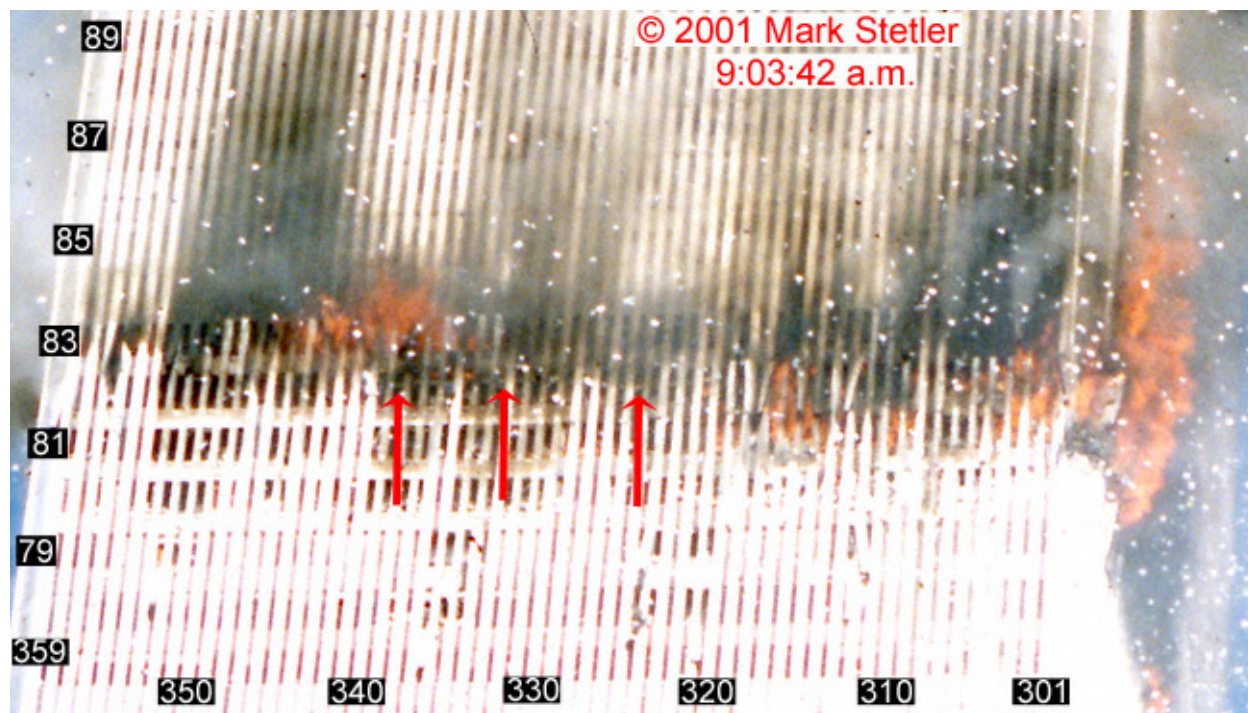
Figure 9–1 shows an image of the east face of WTC 2 recorded at 9:03:42 a.m., which was 43 s after the aircraft impact. The numerous white dots are pieces of paper that were expelled from the building due to the aircraft impact and subsequent fireballs. Extensive fires are visible on the 81st, 82nd, and 83rd floors. On the two lower floors, intense fires, which fill the windows with flame, appear to be nearly continuous from around windows 81-321 and 82-322 to the north edges of the floors. On the 83rd floor, the fires are intense, with considerable flaming outside of windows between windows 83-335 and 83-346. There is also a region with a lower intensity fire nearer the center of the face on the 81st floor, and there is an indication of a small fire near window 80-313 on the 80th floor. Despite the numerous fires present, the amount of smoke being released is relatively small, and it is possible to see most of the east face above the fires.

The intensity levels of the photograph in Figure 9–1 were adjusted to enhance the visibility of an object that is identified by the arrows added to the photograph. A blowup of the area of the photograph including the arrows is provided in Figure 9–2. The object appears as a narrow line that has been draped inside windows on the 82nd floor extending from at least window 82-321 to window 82-339. This hanging object will be observed numerous times in images to be shown below. While it is difficult to identify the object with certainty, the evidence will be strong that it is the end of a part of the 83rd floor concrete floor slab that has been dislodged from the spandrel located above the 82nd floor and has settled downward several feet to appear below the spandrel.

Figure 9-1. A view of the east face of WTC 2 recorded at 9:03:42 a.m. is shown. The original photograph has been rotated, cropped, and enhanced by adjusting intensity levels. Column and floor numbers have been added. The arrows highlight a hanging object observed through open windows on the 82nd floor.

Closer inspection of Figure 9–1 and Figure 9–2 shows that small flames are visible above the object at the tops of windows 82-335 to 82-337. While not as clear as in these windows, similar fires appear to be present elsewhere along the top of the line. Heavy flames are coming from windows on the 83rd floor immediately above this area. This suggests that the flames observed at the tops of windows on the 82nd floor are burning at the base of a fuel source located on top of the hanging object that is fueling the much larger flames visible on the 83rd floor. It is likely that this fuel is on top of the concrete floor slab that was originally attached to the spandrel above the 82nd floor.

The visual evidence supports a conclusion that a substantial length of the concrete floor slab for the 83rd floor along the east facade of the WTC 2 has been dislodged and has come to rest below the spandrel. The edge of the object appears to be continuous, suggesting that even though the floor slab has dropped down, it is essentially intact and is still acting as a single system.

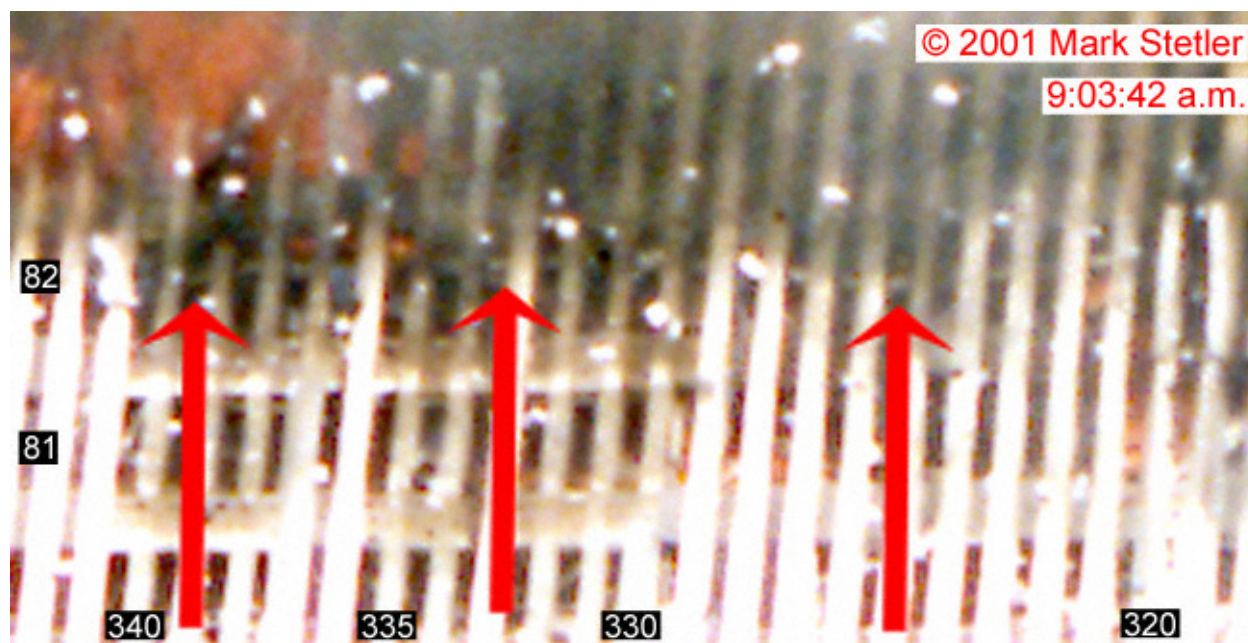
Figure 9-2. A section of the image shown in Figure 9-1 is blown up. The arrows point to the location of an object that is visible through open windows on the 82nd floor on the east side of WTC 2.

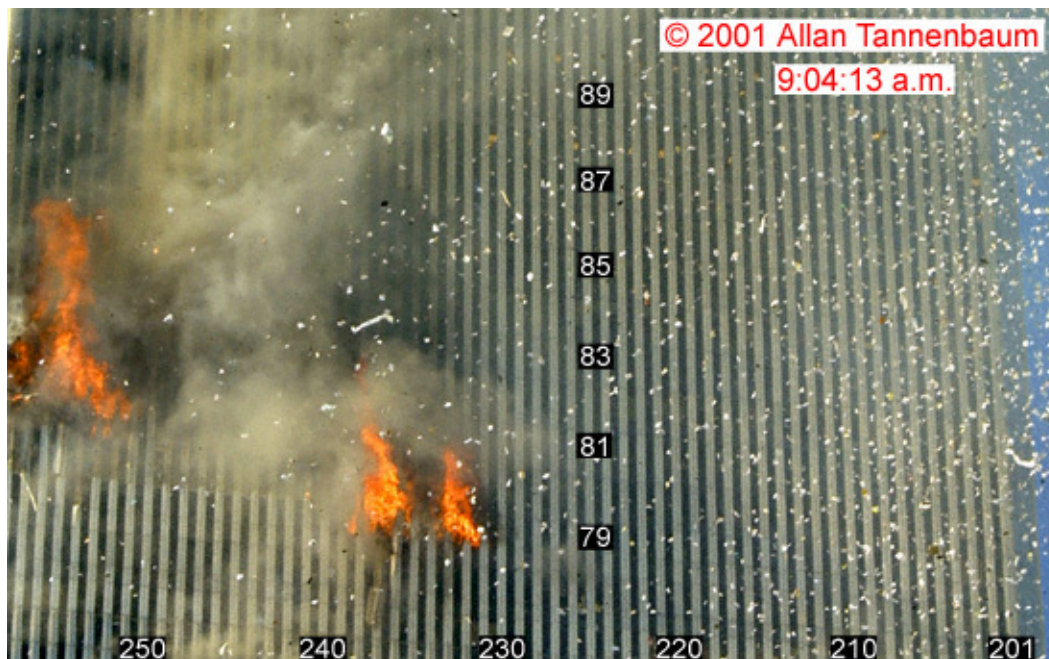
A view of the north face of WTC 2 recorded at 9:04:13 a.m. is shown in Figure 9–3. The large amount of paper expelled from the tower due to the aircraft impact and subsequent fires is apparent. Two areas of intense fire are seen. One of these is located near the east edge of the face on the 81st floor, and the second is on the 79th floor, extending from roughly windows 79-231 to 79-238. In Chapter 7 visual evidence was shown indicating that large piles of debris, presumably a mixture of aircraft and building debris, were present at these two locations. Evidently, these debris piles were ignited during the aircraft impact and subsequent fireballs and continued to burn intensely. Even though there is a large amount of dust evident, there does not appear to be a substantial fire in the region between the two burning areas.

Figure 9-3. This cropped photograph of the north face of WTC 2 was recorded at 9:04:13 a.m. The image intensity levels have been adjusted. Column and floor numbers have been added.

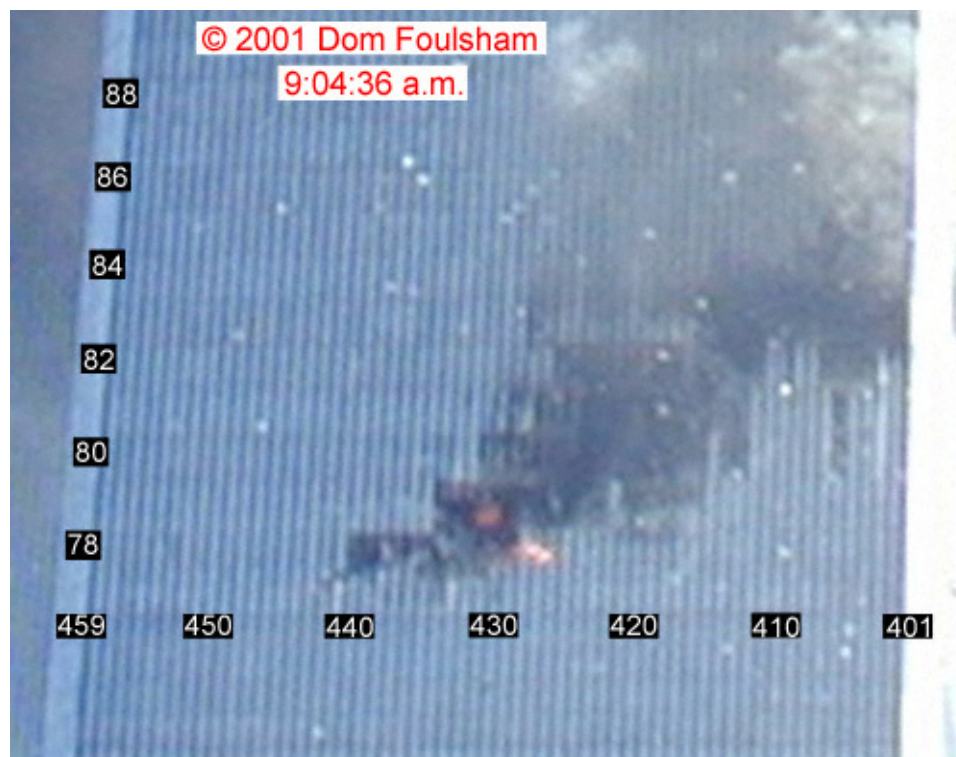
A view of the south face of WTC 2 recorded at 9:04:36 a.m. is shown in Figure 9–4. It was taken 97 s after the aircraft impact on this face. A number of sheets of paper are also visible on this side of the building. The most prominent feature is the damage caused by the aircraft impact. Two areas of bright flame are evident in the image on the 78th and 79th floors. On the 78th floor, the fire is located just to the right of the cavity generated by the aircraft impact, while on the 79th floor the fire appears to be burning within the cavity. On the 82nd floor there appears to be an orange glow from windows 82-420 to 82-425, suggesting that a fire is present in this area as well.

Figure 9-4. This cropped photograph shows the south face of WTC 2 at 9:04:36 a.m. Column and floor numbers have been added.

There is relatively little smoke coming from windows on the south face at this time. For later comparison purposes, note that the entire lengths of the 81st and 82nd floors can be seen and that very little smoke is evident coming from windows on these floors. The only significant plume of smoke is coming from the 83rd floor near the east edge of the face.

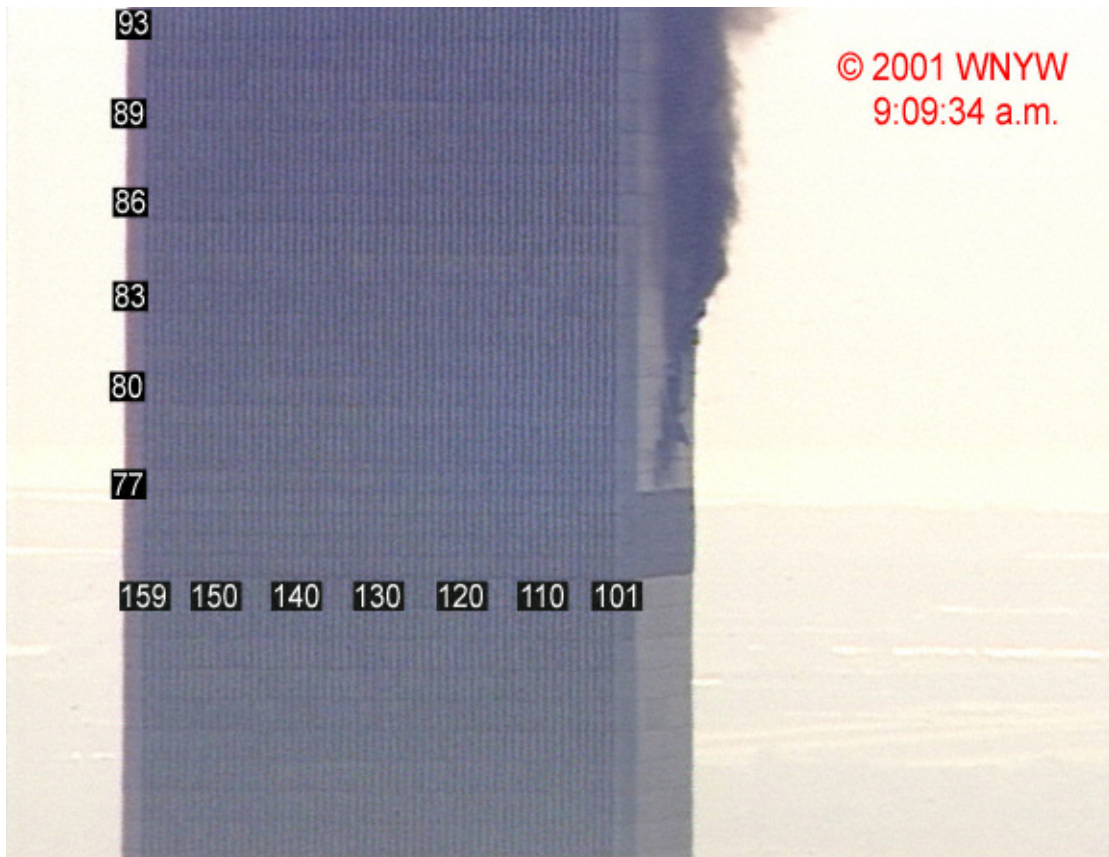
The database does not contain clear images of the west face of WTC 2 in the early period following the aircraft impact. Figure 9–5 shows an image of the face taken from a video recording made from a news helicopter at 9:09:34 a.m. At this time there was no visible smoke or fire on the face. This is consistent with the conclusion in Chapter 7 that the aircraft impact and subsequent fireballs caused no visible damage to the west face of WTC 2.

**Figure 9-5. This image of the west face of WTC 2 was captured from a video shot from a news helicopter at 9:09:34 a.m. Column and floor numbers have been added.**

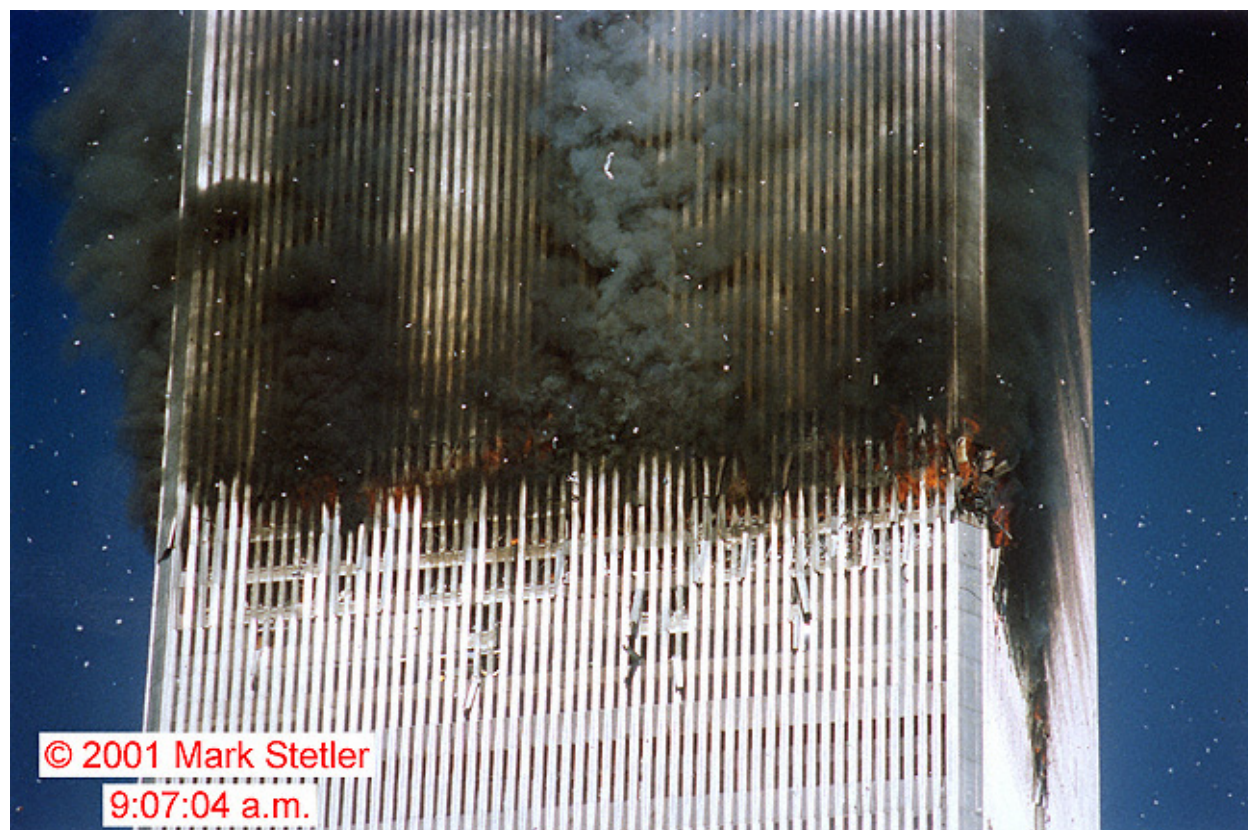
**Figure 9-6. This photograph showing the east face of WTC 2 was recorded at 9:07:04 a.m.**

A close-up view of the east face of WTC 2 recorded at 9:07:04 a.m. is shown in Figure 9-6. During the 3 min 20 s since Figure 9-1 was taken, the fire distribution on the face has changed. The large fires that were burning earlier on the 81st, 82nd, and 83rd floors appear to have died down somewhat. A new area of intense fire has appeared on the 82nd floor just to the south of where the large fire was visible on the 83rd at the earlier time.

A substantial increase in the amount of smoke coming from open windows is evident when the two photographs of the east face are compared. The smoke appears to be coming from two separate locations on the 82nd floor. Videos of the east face show that heavy smoke appeared first from the area on the south side of the face, increasing rapidly around 9:04:30 a.m. The smoke flow coming from windows just to the north of the center of the face increased markedly about 50 s later.

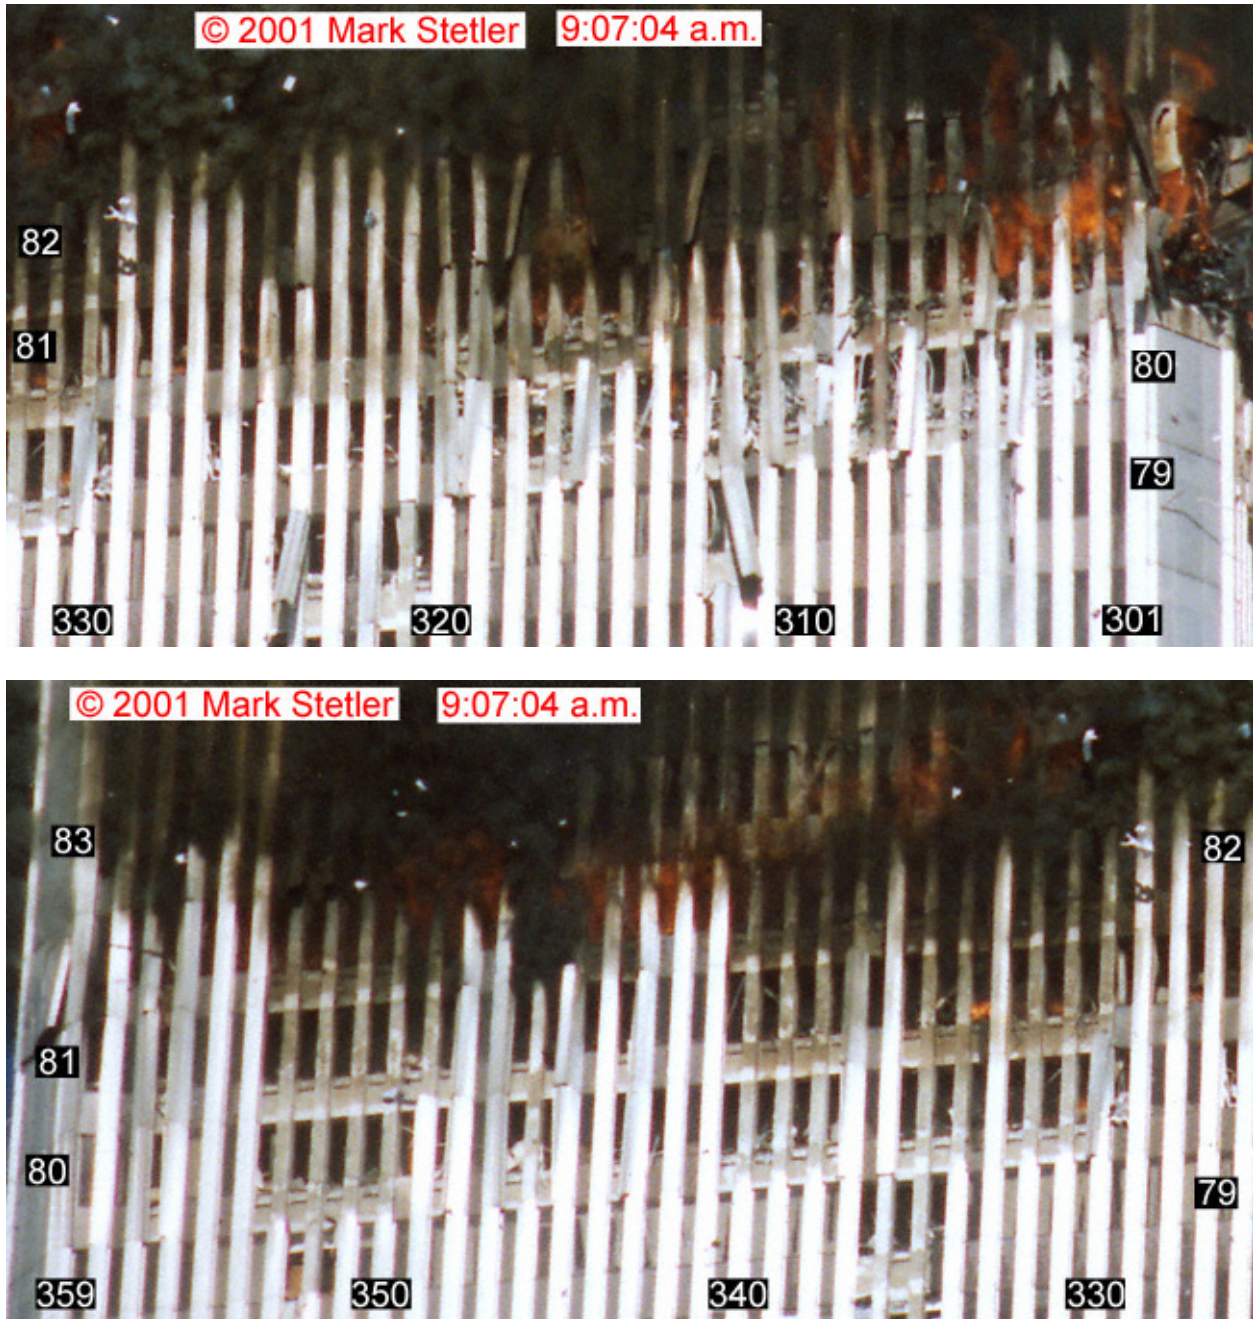
The image in Figure 9-6 provides a great deal more resolution than is evident from the way it has been sized. Figure 9-7 shows blowups taken from the photograph of the northern and southern halves of the east face for the floors where fires were present. The north side is at the top of the figure. In this image the damage to the aluminum façade is evident. The debris that has been piled along the east wall in the northeast corners on the 80th and 81st floor is visible. There is also a large amount of debris protruding from the opening created by removing the aluminum panel from the northeast corner of the 81st floor.

**Figure 9-7. These two images show blowups of the north and south sides of the east face of WTC 2 taken from the photograph included in Figure 9-6, which was shot at 9:07:04 a.m. Column and floor numbers have been added.**

Heavy fires are burning in the northeast corners of the 81st and 82nd floors. On the 81st floor flames are coming from windows 81-301 to 81-304 as well as from the northeast corner where the aluminum panel has been removed. Lower intensity flames are evident in many windows further to the south, extending at least as far as the last visible window, 81-332. It is likely that the fire is continuous across this entire length. On the 82nd floor flames are coming from windows 82-301 to 82-309. Flames further to the south do not appear to be as widespread as on the 81st floor, but there is much more smoke coming from open windows on this floor. The smoke flow is particularly heavy from windows 82-323 to 82-332. The

A blowup of the southern side of the fire floors is included at the bottom of Figure 9-7. Flames are visible on the 83rd floor over a length from near window 83-331 to window 83-338. The intensity of these flames has died down considerably from that observed at the earlier time in Figure 9-1. It can be seen that a considerable amount of the aluminum facing on this floor has been removed.

Unlike in the earlier photograph, intense flames are now visible in windows 82-341 to 82-349. Flames fill these windows and in many cases extend from the openings. Heavy black smoke is coming from the flame area as well as from windows immediately below on the 81st floor, particularly window 81-345 and window 81-346. Smoke is also coming from numerous windows to the north of the visible fire on the 82nd floor. This smoke has obscured the windows where the hanging object was identified in Figure 9-1 and Figure 9-2. Note that the aluminum panel on the southeast corner of this floor is pushed out, but is still attached.

On the 81st floor the last window to the south where a low-intensity fire is observed is window 81-333. It is interesting that despite the fact that there is a great deal of damage to the aluminum façade on this floor, there are several windows for which the glass is still in place. The small spot fire present in window 80-330 can be seen in the overlapping lower image as well. Several window panes are also still in place on this floor. No fire or smoke is visible on this half of the 79th floor.

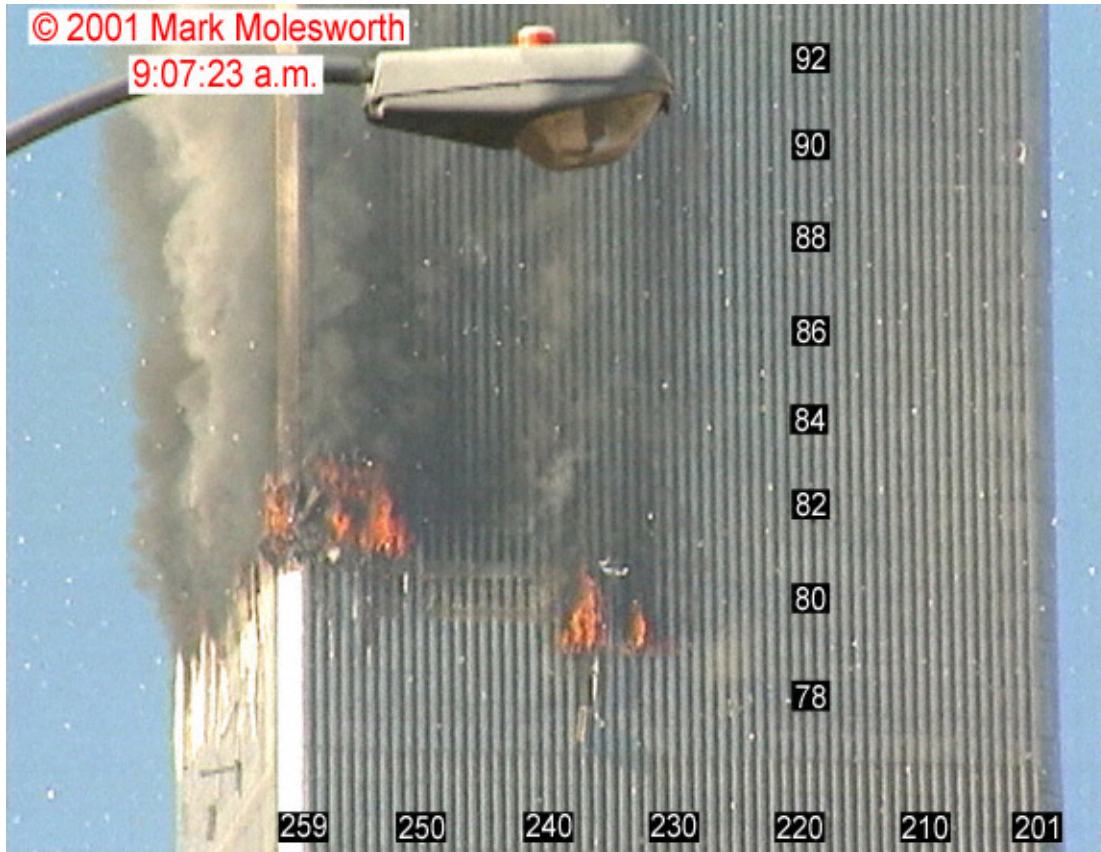
Figure 9-8 shows the north face of WTC 2 at 9:07:23 a.m. This is 3 min and 10 s later than the image of the north face included in Figure 9-3. The view of the fires in the current image is more complete due to the angle and distance from which it was shot. The two large fires that were observed on the 79th and 81st floors at the earlier time continue to burn vigorously. The fire on the 79th floor still consists of two large tongues of flame at the same locations however, flames are visible further to the west than at the earlier time, now reaching at least as far as window 79-228. In the earlier photograph, windows 79-228 and 79-229 appeared to have intact glass. The intense fire on the east edge of the 81st floor is in roughly the same location as earlier. In Figure 9-3 it was not possible to determine whether the 82nd floor was burning. It is clear in the later image that there is a fire on the 82nd floor, with flames coming from windows 82-252 to 82-258. It was difficult to see this area immediately following the aircraft impact because of the amount of debris released and the large flames present on the 81st floor. A review of images indicates that the 82nd floor was burning in this corner as early as 9:04:25 a.m.

**Figure 9-8. This image captured from a video shows the north face of WTC 2 at 9:07:23 a.m. Column and floor numbers have been added.**

Figure 9–8 provides a good view of much of the north face with sufficient resolution to resolve details on the face. For instance, the open windows on the 78th floor near window 78-225 can be discerned. There is no indication of fire or smoke at locations removed from the area that was originally damaged during the aircraft impact and subsequent fireballs.

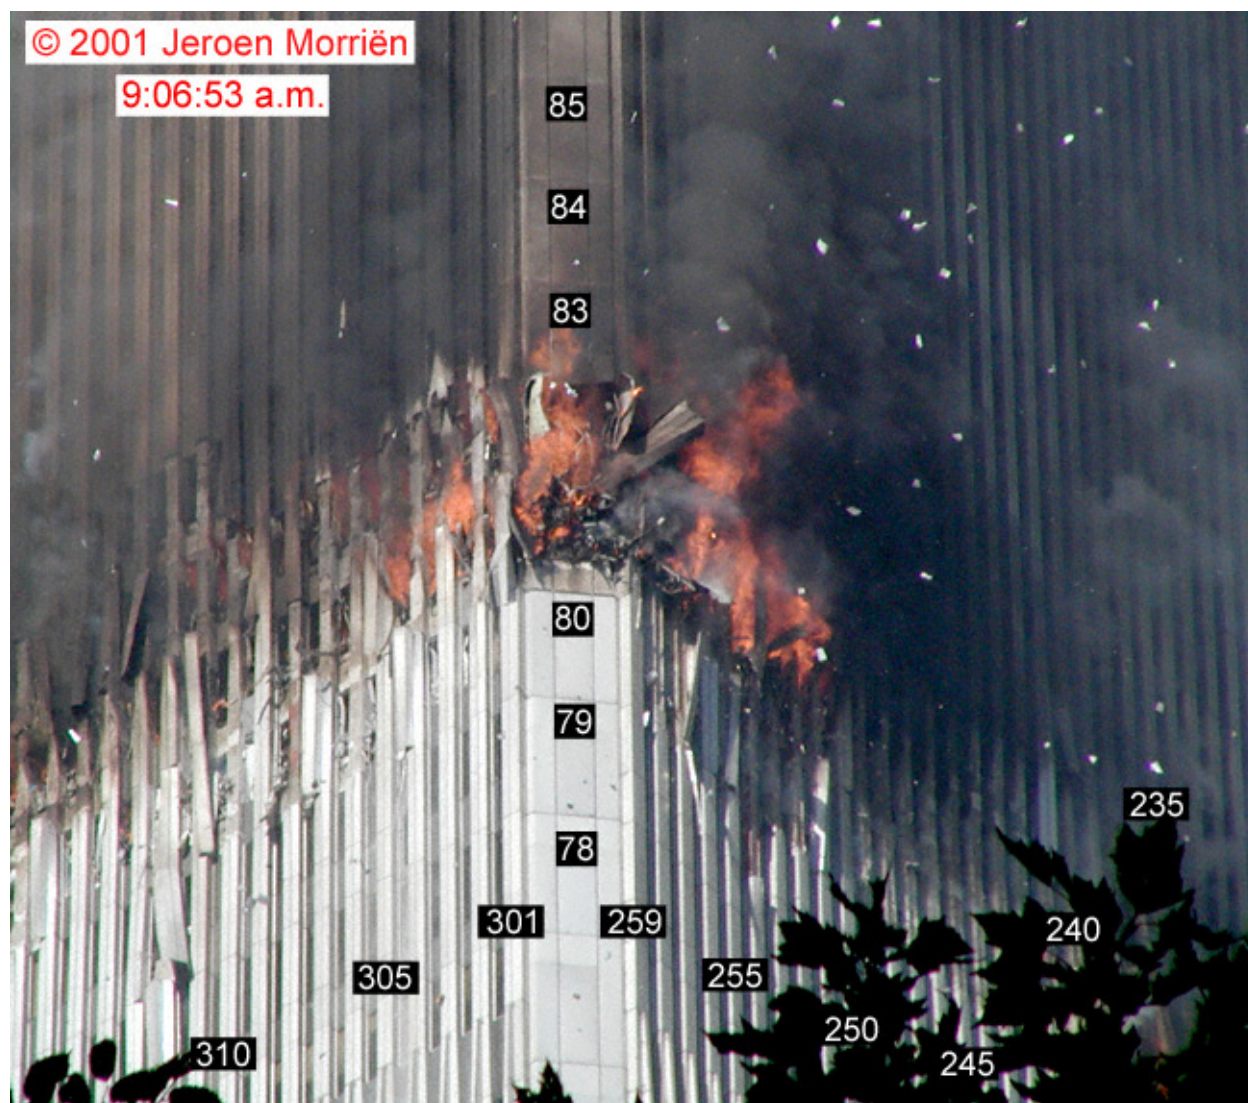
An image of the fires on north and east faces shot from the northeast at 9:06:53 a.m. is shown in Figure 9–9. It provides a good view of the debris that was protruding from the northeast corner of the 81st floor, as well as an indication of the actual extent and intensity of the fires burning in the northeast corners of the 81st and 82nd floors. The cold spot on the north face is easily identified from this angle.

**Figure 9-9.** This cropped photograph showing the northeast corner of WTC 2 was taken at 9:06:53 a.m. The image has been enhanced by adjusting the intensity levels. Column and floor numbers have been added.

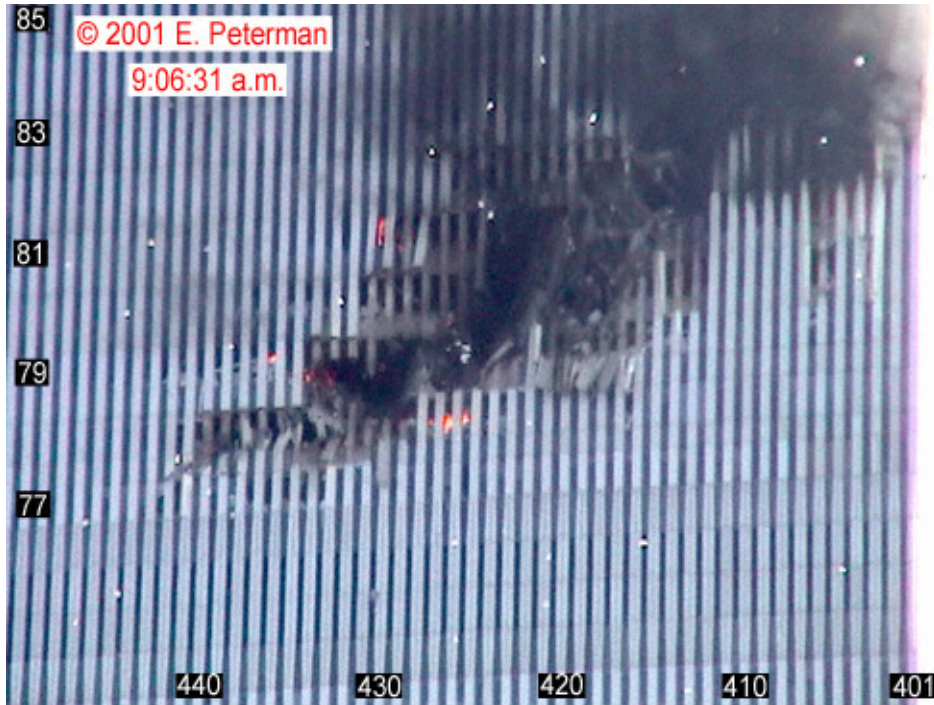
An image of the south face of WTC 2 taken from a video recorded at 9:06:31 a.m. is shown in Figure 9–10. This is slightly less than two minutes later than the image shown in Figure 9–4. Even though the latter image is clearer and shows more detail, it can still be seen that the appearance of the face has changed somewhat during this short period. A new fire has appeared on the 81st floor near window 81-430 that was not apparent earlier. The fire that was burning within the cavity created by the aircraft impact on the 79th floor seems to have moved toward the west and can now be seen on top of a pile of debris through open window 81-436, as well as at multiple locations on the debris within the impact cavity. In the later image there is no indication of a fire burning on the 82nd floor above the aircraft impact cavity.

In Figure 9-10, smoke is coming from open windows to the east of the aircraft impact cavity on the 81st floor, and there is an indication of flames in the area. In the earlier photograph, this area was clear of smoke, and some details on this floor as well as the one above could be identified. Apparently, a fire has grown quickly on the 81st floor in this area. Interestingly, a photograph of the east face taken around this time (see Figure 9-7) shows very little smoke and no visible flame near the south edge of the face. This suggests that the fire growing at this location was ignited near the aircraft impact location and is moving toward the east.

Figure 9-10. This image showing the south face of WTC 2 is a frame captured from a video recorded at 9:06:31 a.m. It has been enhanced by adjusting the intensity levels, and column and floor numbers have been added.

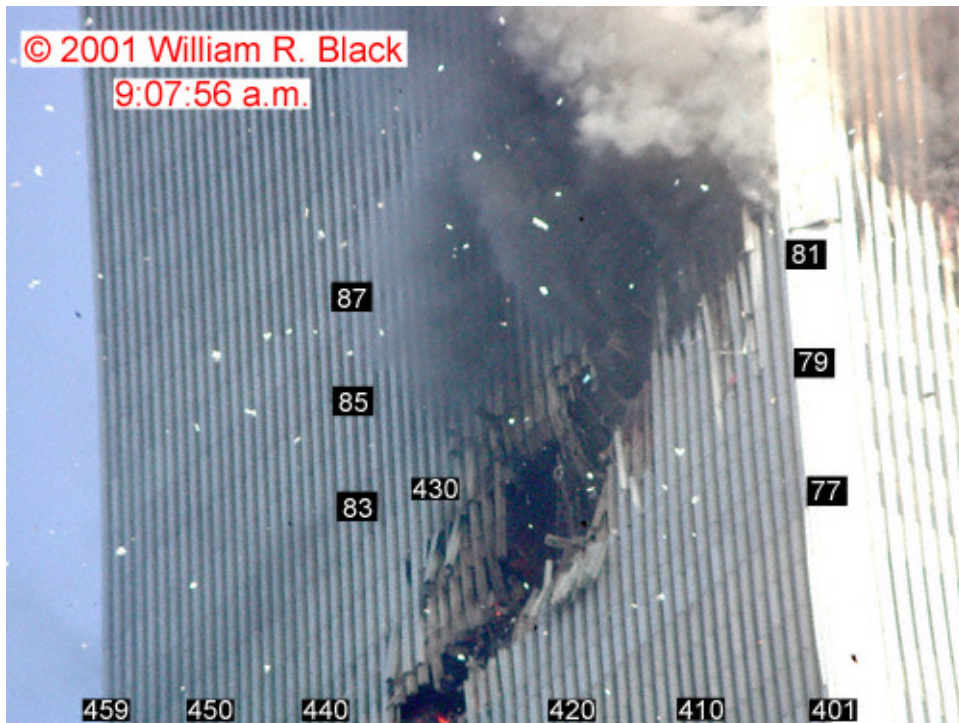
Another view of the south face at roughly the same time is shown in Figure 9-11. It was shot from further east than Figure 9-10. From this angle fires are visible at multiple spots inside the aircraft impact cavity, including locations corresponding to the 78th, 79th, and 80th floors. The smoke coming from the windows to the east of the aircraft impact cavity on the 81st floor is also visible. Apparently, the fires

Figure 9-11. This photograph of WTC 2 was taken at 9:07:56 a.m. from the southeast and shows the south face and a portion of the east face. The intensity levels have been adjusted, and column and floor numbers have been added.

growing on this floor are also venting through the aircraft impact cavity since a large amount of smoke is flowing from the opening just to the west. This photograph confirms that little smoke and no flames are visible coming from windows on the 81st floor of the east face that are adjacent to this area.

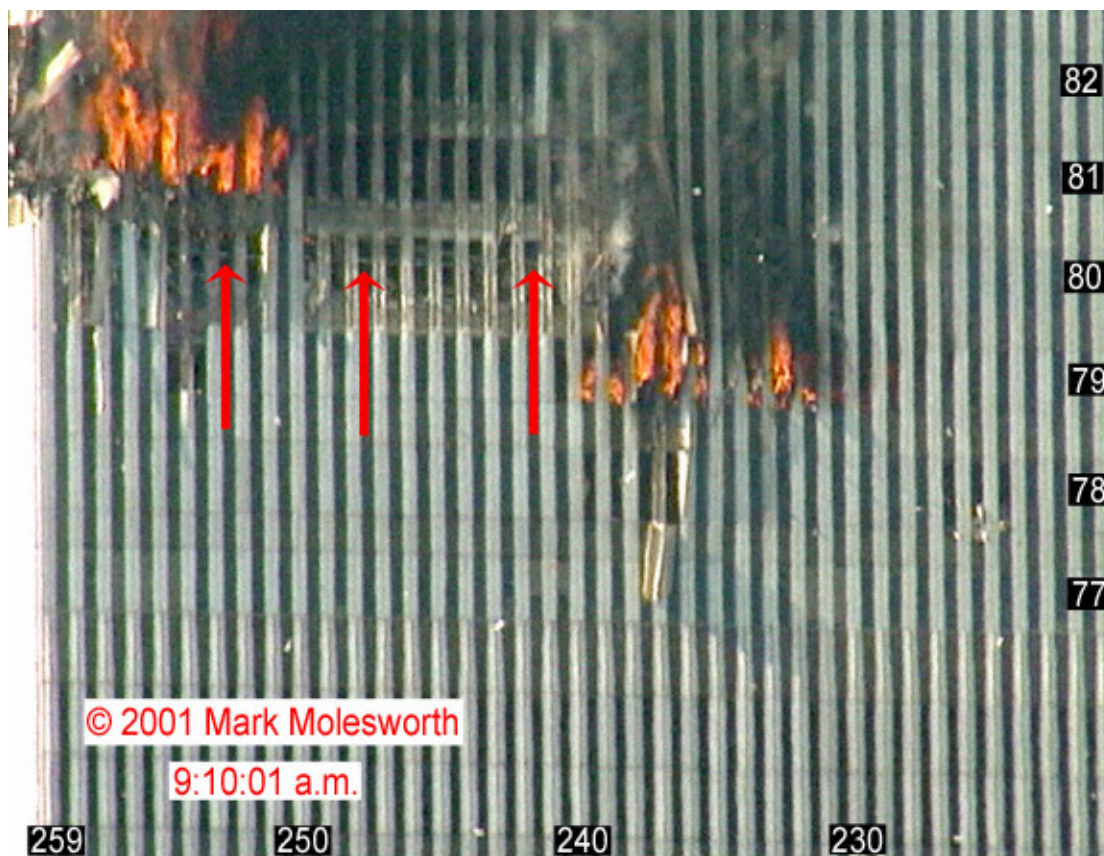
At 9:10:01 a.m. a videographer recorded a closer view of the north face of WTC 2 than those presented thus far. Figure 9–12 shows a frame captured from this video. The image shows that the fires burning on the 79th, 80th, and 81st floors have not changed markedly since 9:07:23 a.m. (see Figure 9–8). The cold spot is also distinct. The increased resolution of Figure 9–12 allows a detail to be resolved that was not easily identified in the earlier images. There appear to be two objects hanging across a length of open windows on the 80th floor. The arrows added to the image indicate these objects. One of the objects appears as a line running from at least window 80-255 to window 80-243. The second object also appears as a curved line. It is visible above the first object starting near the top of window 80-247 and extending west to at least window 80-241.

**Figure 9-12.** An image of the north face of WTC 2 captured from a video recording at 9:10:01 a.m. is shown. The intensity levels of the image have been adjusted, and column and floor numbers have been added. The arrows highlight hanging objects observed through open windows on the 80th floor.

Closer inspection of Figure 9–12 shows that flames are visible above the first object in windows 80-249, 80-252, and 80-253. These fires have similar locations and appearances to the numerous fires that were observed at the tops of windows in WTC 1 (see Chapter 8) and were attributed to burning thermal insulation located above the windows. In this case this explanation seems unlikely since the aluminum façade has been removed from the columns adjacent to these windows. Using Figure 9–12 as a guide, Figure 9–8 was reviewed more carefully to look for indications of these objects and fires. It is possible to barely discern the first of the objects, and the fires above the objects are clearly visible at the earlier time.

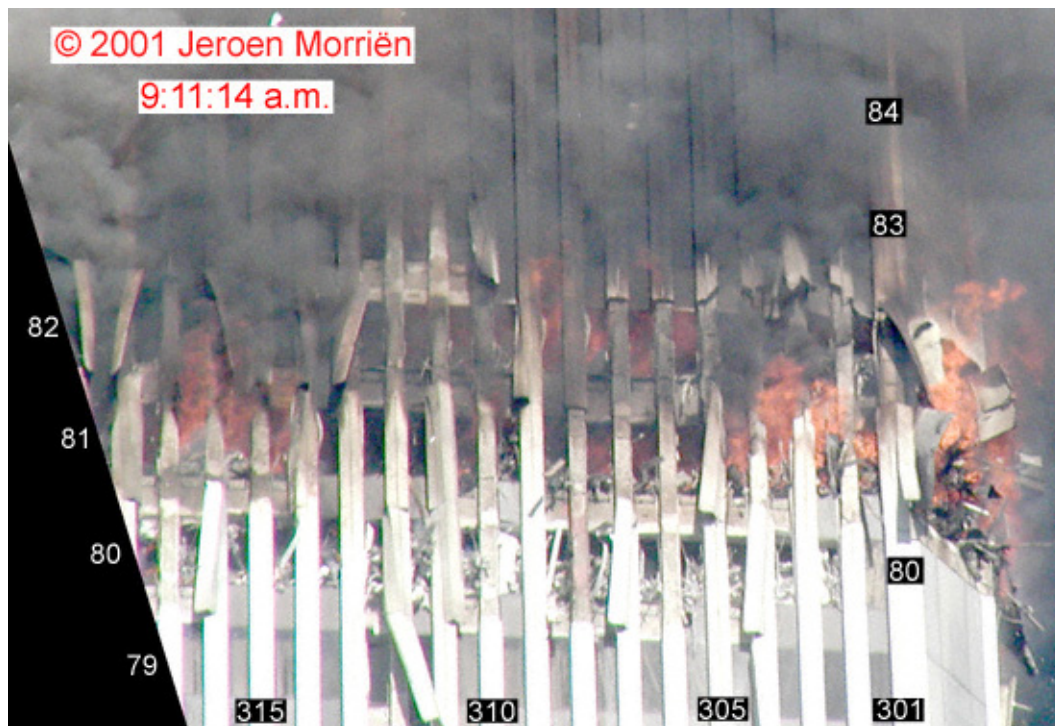
A close-up view of the northern portion of the east face of WTC 2 at 9:11:14 a.m. is shown in Figure 9–13. The debris piles on the 80th and 81st and in the opening on the northeast corner of the 81st floor are particularly clear. The fires on the 81st and 82nd floors continue to burn intensely. The only fire visible on the 80th floor is in window 80-317. Most of the glass is intact for windows on the 79th floor.

Figure 9-13. This photograph shows the northern portion of the east face of WTC 2 at 9:11:14 a.m. The image has been cropped and rotated, and the intensity levels have been adjusted. Column and floor number have been added.

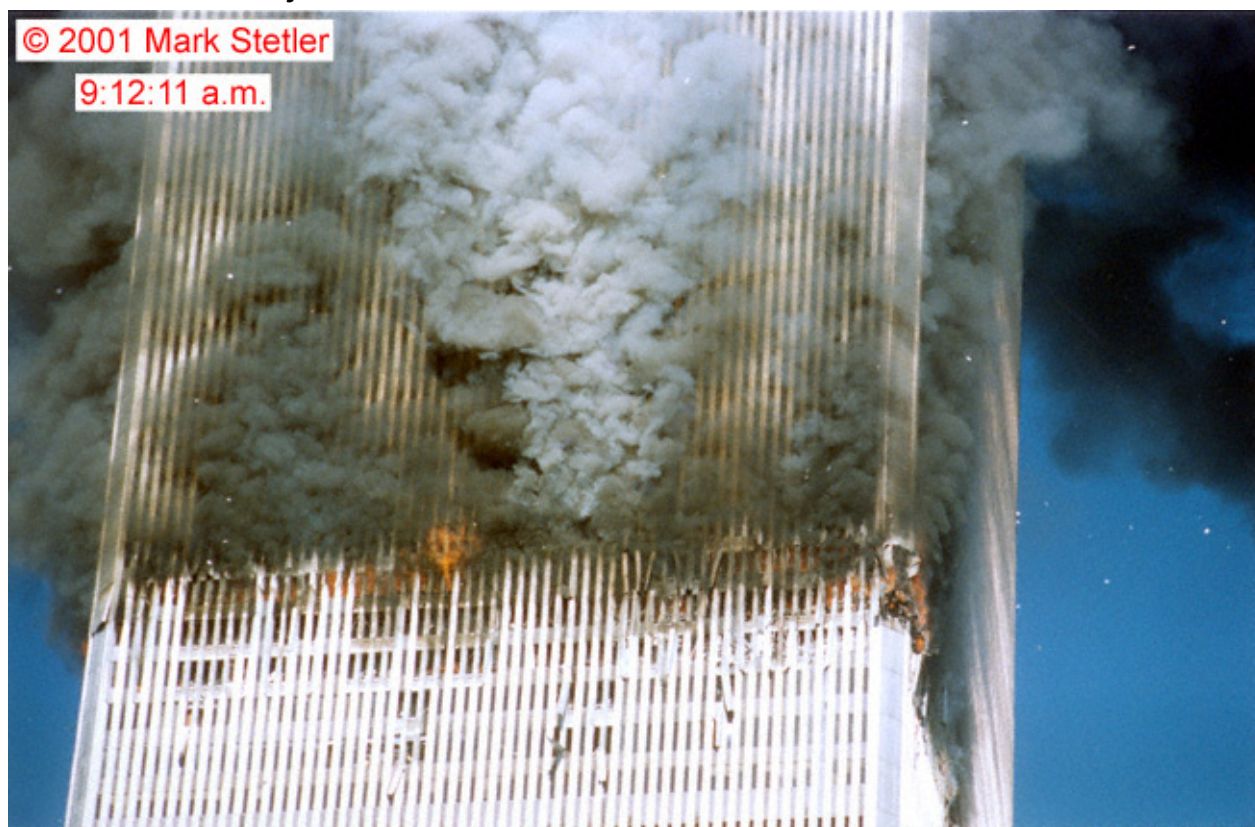
Another photograph of the east face of WTC 2 taken at 9:12:11 a.m. is shown in Figure 9–14. Figure 9–15 includes blowups of the north and south sides of the fire floors from this photograph. Comparison of Figure 9–14 with the similar photograph in Figure 9–6, which was taken just over 5 min earlier, shows that the heavy smoke flows from near the center and closer to the southern edge of the face have continued. In Figure 9–14, it appears as if a portion of the smoke flow near the center may be coming from the 83rd floor. It can also be seen that the fire burning on the southern half of the 81st floor has grown substantially.

Figure 9-14. This photograph showing the east face of WTC 2 was recorded at 9:12:11 a.m.

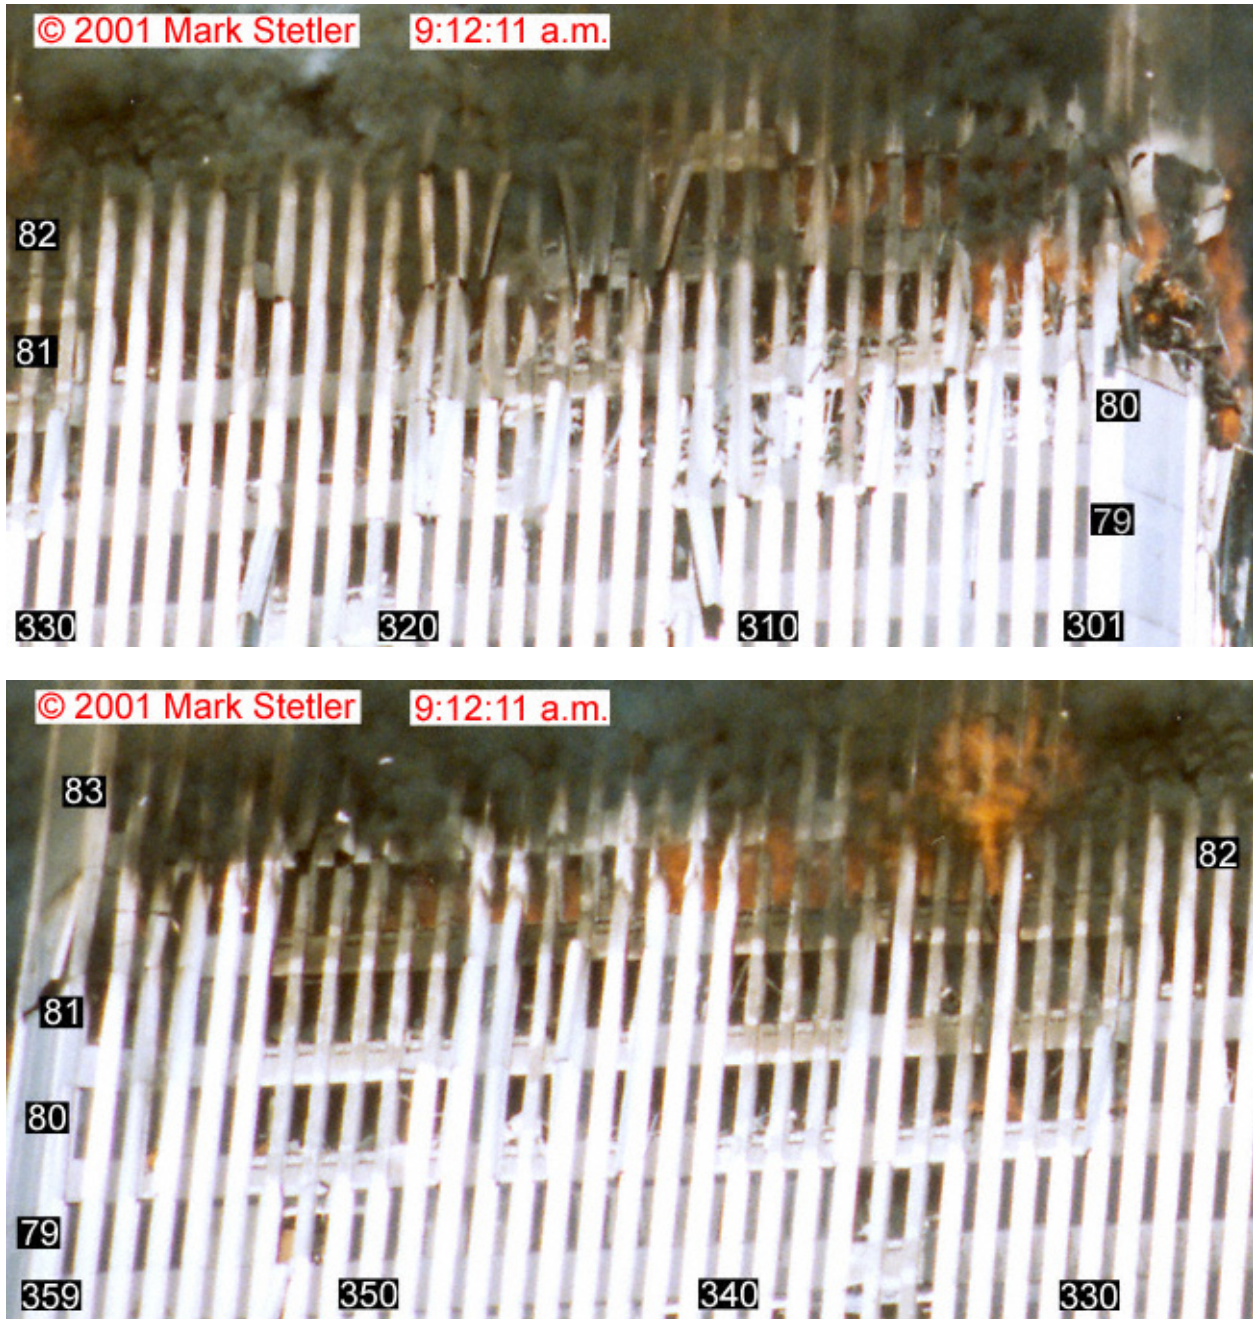
**Figure 9-15.** These two images show blowups of the north and south sides of the east face of WTC 2 taken from the photograph included in Figure 9-14, which was shot at 9:12:11 a.m. Column and floor numbers have been added.

The fire spread during the period is more easily characterized by comparing the blowups of the southern part of the face shown in Figure 9-7 and Figure 9-15. At the earlier time, flames were visible on the 82nd floor in windows 82-341 to 82-349. By 9:12:11 a.m., the flames had spread to cover a length of the floor, running from window 82-332 to window 82-350. At the earlier time, smoke was coming from some of the windows where fire has now appeared. This is likely an indication that growing fires were near these windows at 9:07:04 a.m. As the fires to the north have grown larger, the earlier fires in windows 82-341 to 82-349 have decreased in intensity, as reflected by their external flame lengths. This

The close up views of the north side of the east face shown at the tops of Figure 9-7 and Figure 9-15 look very similar. There appears to have been a slight decrease in the intensity of the fires burning in the northeast corners of the 81st and 82nd floors. Two small spot fires burning on the 80th floor also seem to have grown smaller.

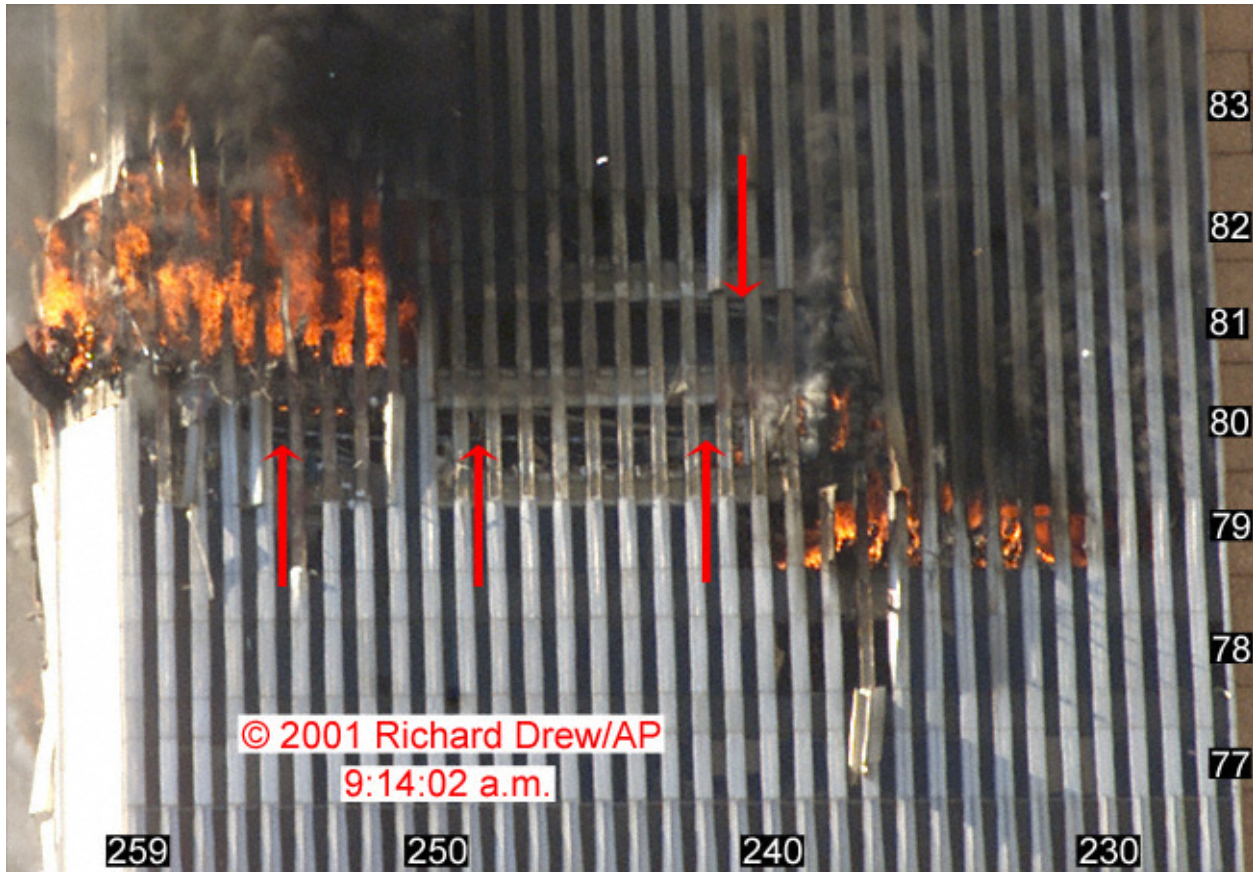
Figure 9-16 shows a close-up view of the north face of WTC 2 taken at 9:14:02 a.m. This is just over 4 min later than the image shown in Figure 9-12. This photograph provides somewhat higher resolution than the earlier image. The arrows point to objects that appear to be hanging across open windows on the 80th and 81st floors. The area of the image containing the arrows is blown up in Figure 9-17.

Even though the later image has higher resolution and shows more detail, a comparison of Figure 9-12 and Figure 9-16 indicates that the locations of the hanging objects identified in Figure 9-12 have not shifted appreciably during the 4 min period between the photographs. There are additional hanging objects resolved in the later photograph (seen most clearly in Figure 9-17) that are not easily identified in Figure 9-12. In addition to the two hanging objects on the 80th floor that were previously described, there is another similar object visible on the 81st floor near the tops of windows 81-239 to 81-242. This hanging object appears to consist of two closely spaced lines. There is yet another object in windows 80-251 to 80-254 that is below the much longer object that is visible hanging across window 80-242 to window 80-256.

**Figure 9-16.** This close-up image of the north face of WTC 2 was taken at 9:14:02 a.m. The original photograph has been cropped and rotated, and the intensity levels have been adjusted. Column and floor numbers have been added. The arrows highlight hanging objects observed through open windows on the 80th and 81st floors. The brown area to the right is the eastern edge of WTC 7.

Most of the cold spot continues to be smoke and fire free. In the lower right-hand corner of the area a small fire is now visible on the 80th floor in windows 80-238 to 80-240, burning on a debris pile. The image in Figure 9-16 has sufficient resolution to determine the condition of windows. All of the windows on the 83rd floor immediately above the cold spot have glass in place while windows 79-241 to 79-249 on the 79th floor below the spot were also closed at this time.

The debris pile on the 79th floor continues to burn vigorously. Comparison of Figure 9-12 and Figure 9-16 shows that flame lengths are decreasing slowly. This fire is visible in the same windows as earlier and does not appear to be spreading in either direction along the north side of the building.
